Attachment to replacement bulletin february 14 2003

## Color check

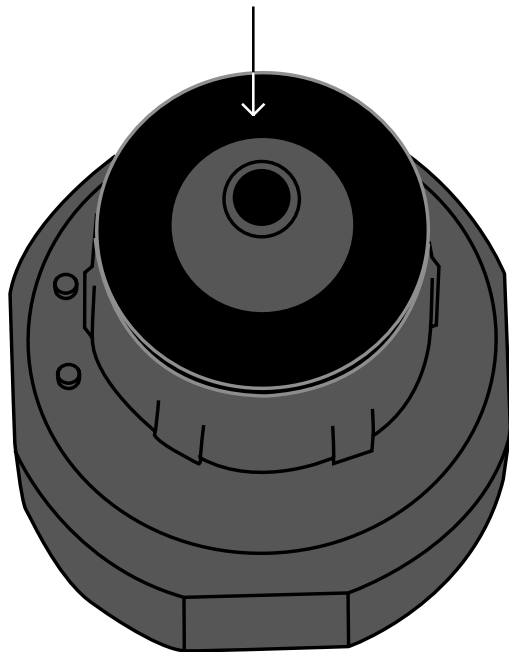
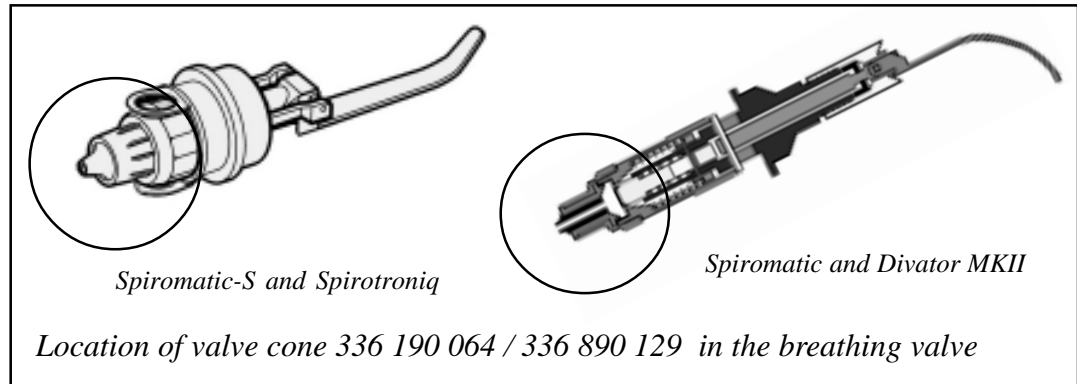
The valve cone assembly in question has a silicone sealing that is transparent. If the silicone sealing is red, blue or white it does not need to be replaced.
